INSTALLATION RESTORATION PROGRAM

CLOSURE ASSESSMENT REPORT FOR UST REMOVALS AT SITES 4 AND 5 - PETROLEUM, OILS, AND LUBRICANTS FACILITY

VIRGINIA AIR NATIONAL GUARD
192nd FIGHTER GROUP
RICHMOND INTERNATIONAL AIRPORT
SANDSTON, VIRGINIA

FINAL
NOVEMBER 1996

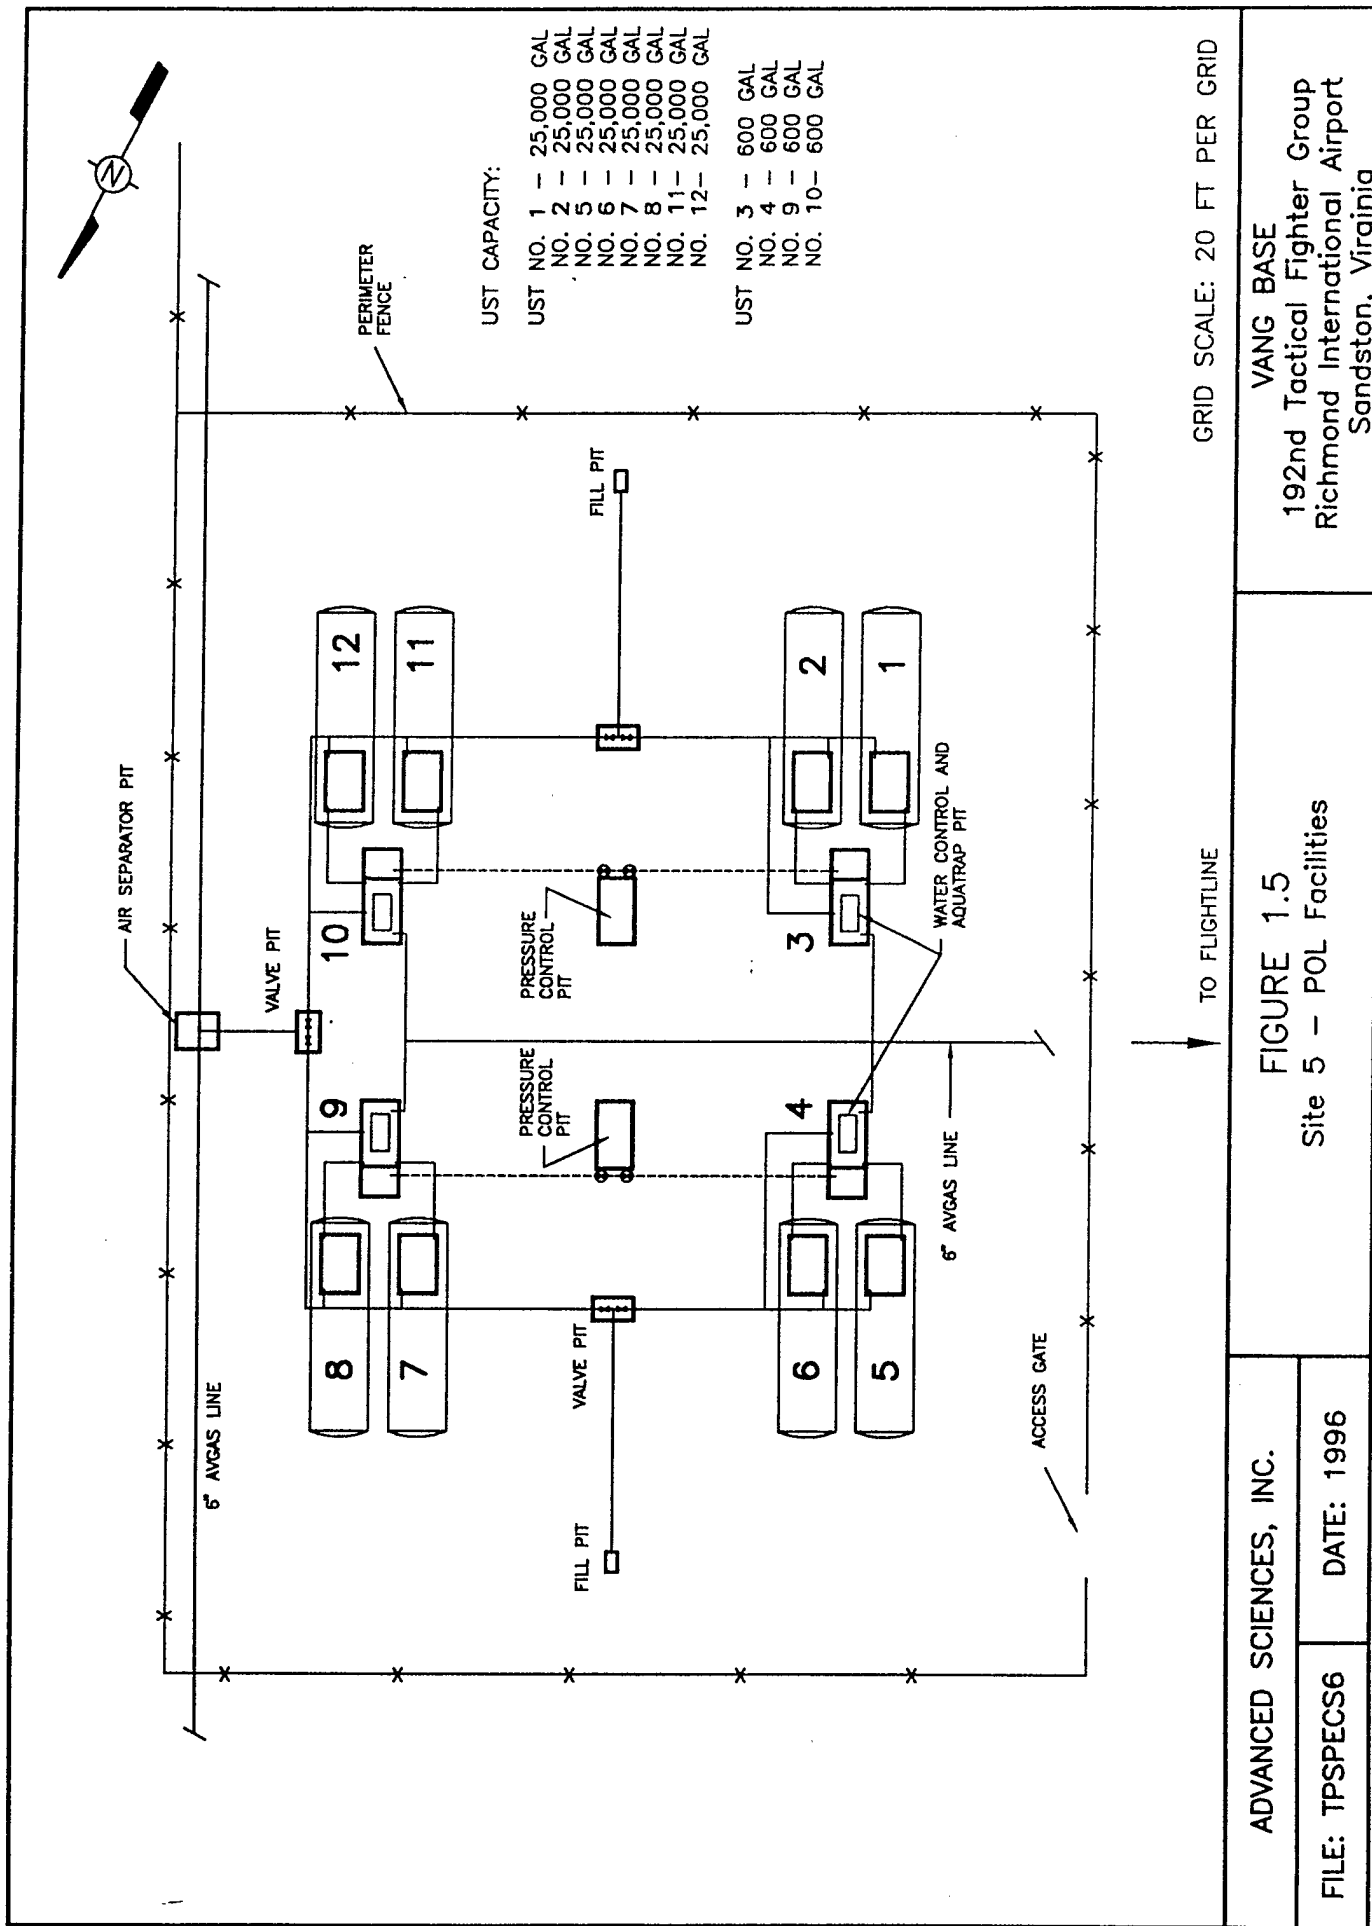
ADVANCED SCIENCES, INC.		FIGURE 1.5 Site 5 - POL Facilities	VANG BASE 192nd Tactical Fighter Group Richmond International Airport Sandston, Virginia
FILE: TPSPCS6	DATE: 1996

As shown in Figure 1.5, the Site 5 POL facility, inactive since 1954, consists of eight 25,000gal USTs, four 600gal USTs, reinforced concrete structures consisting of eight tank manhead pits, four aquatrap pits, two pressure control pits, three valve pits, two fill pits, one air separator pit, and associated fuel distribution piping and equipment.

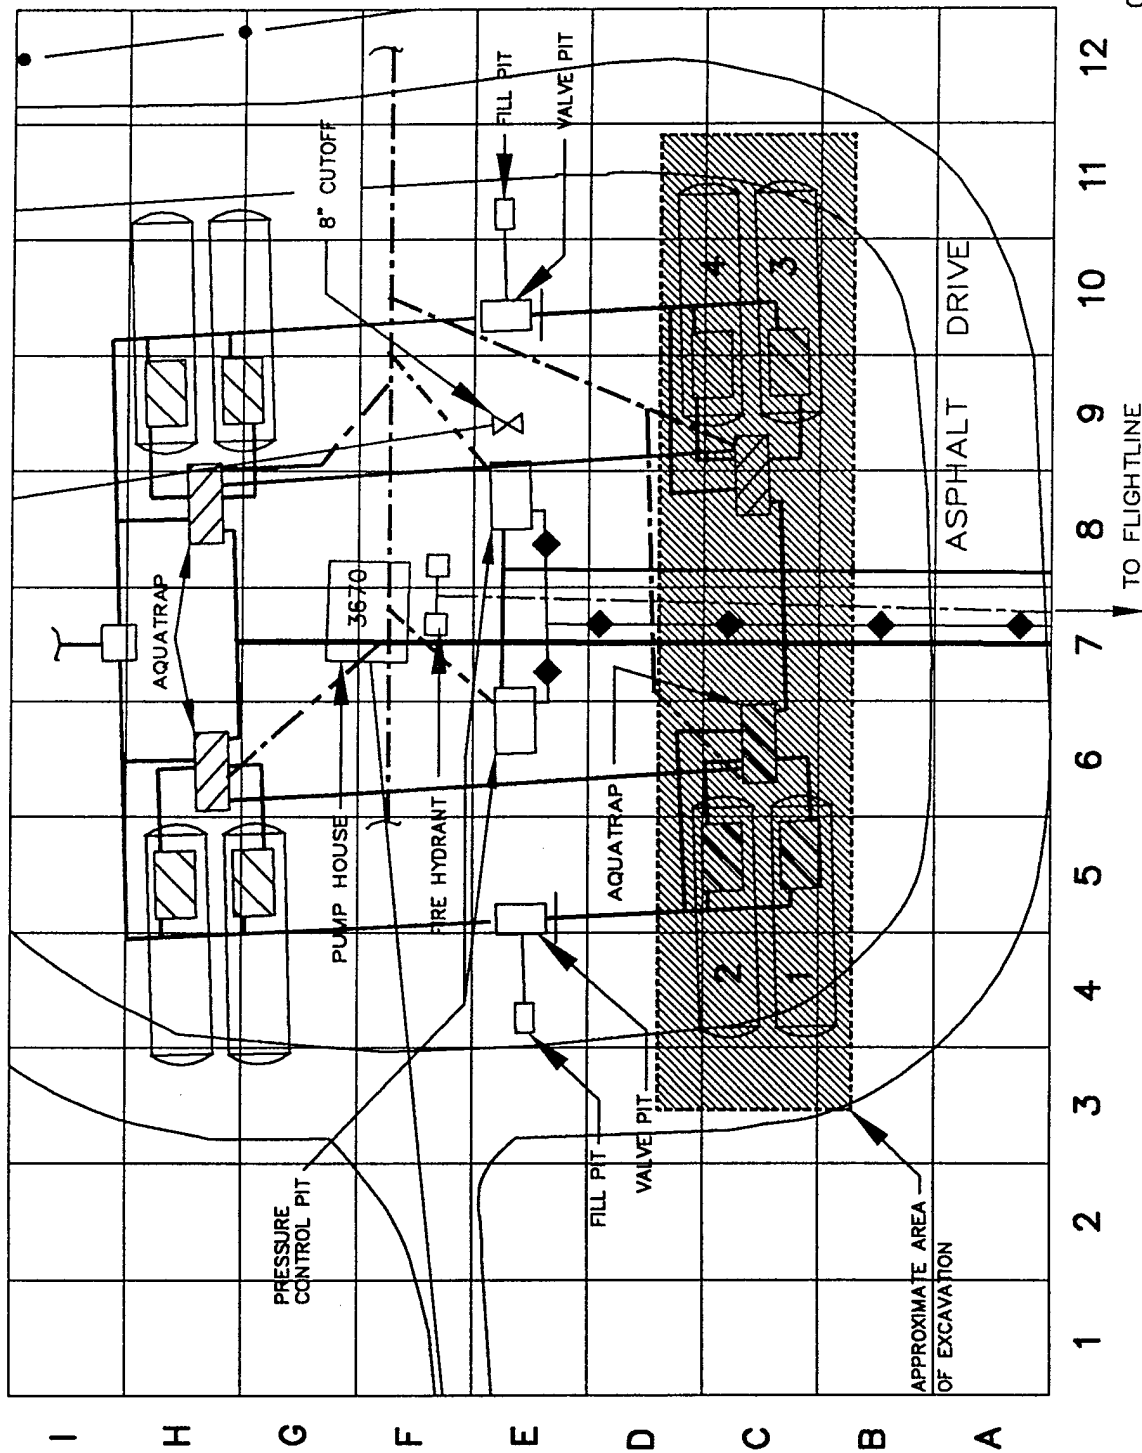
Figure 3.1 depicts the USTs, tank manheads, valve pits, and associated fuel transfer piping that were removed from the inactive side of the Site 4 facility. Section 3.3.1 details closure activities associated with the petroleum USTs (Tank Nos. 1, 2, 3, and the 600gal tank), while Section 3.3.2 details closure activities associated with Tank No. 4. Selected photographs of closure activities conducted at Site 4 are shown in Appendix A.

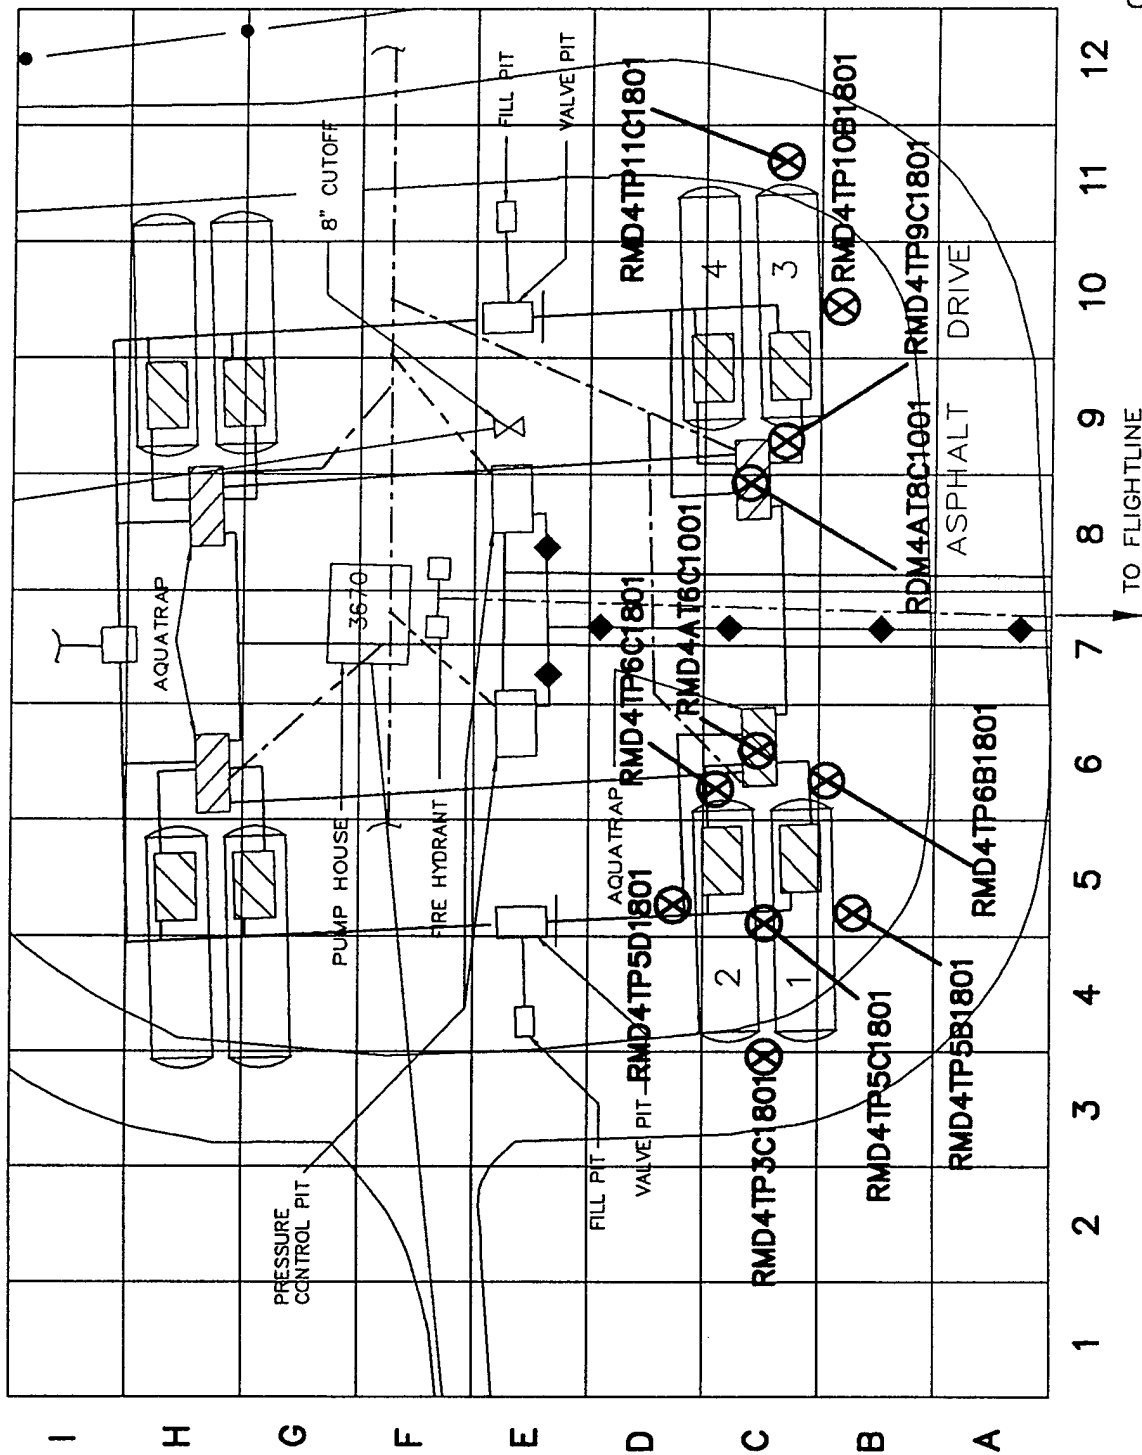
FIGURE 3.2

Site 4 - Sample Locations, UST Pit Nos. 1,2,3,
and Aquatrap Pits

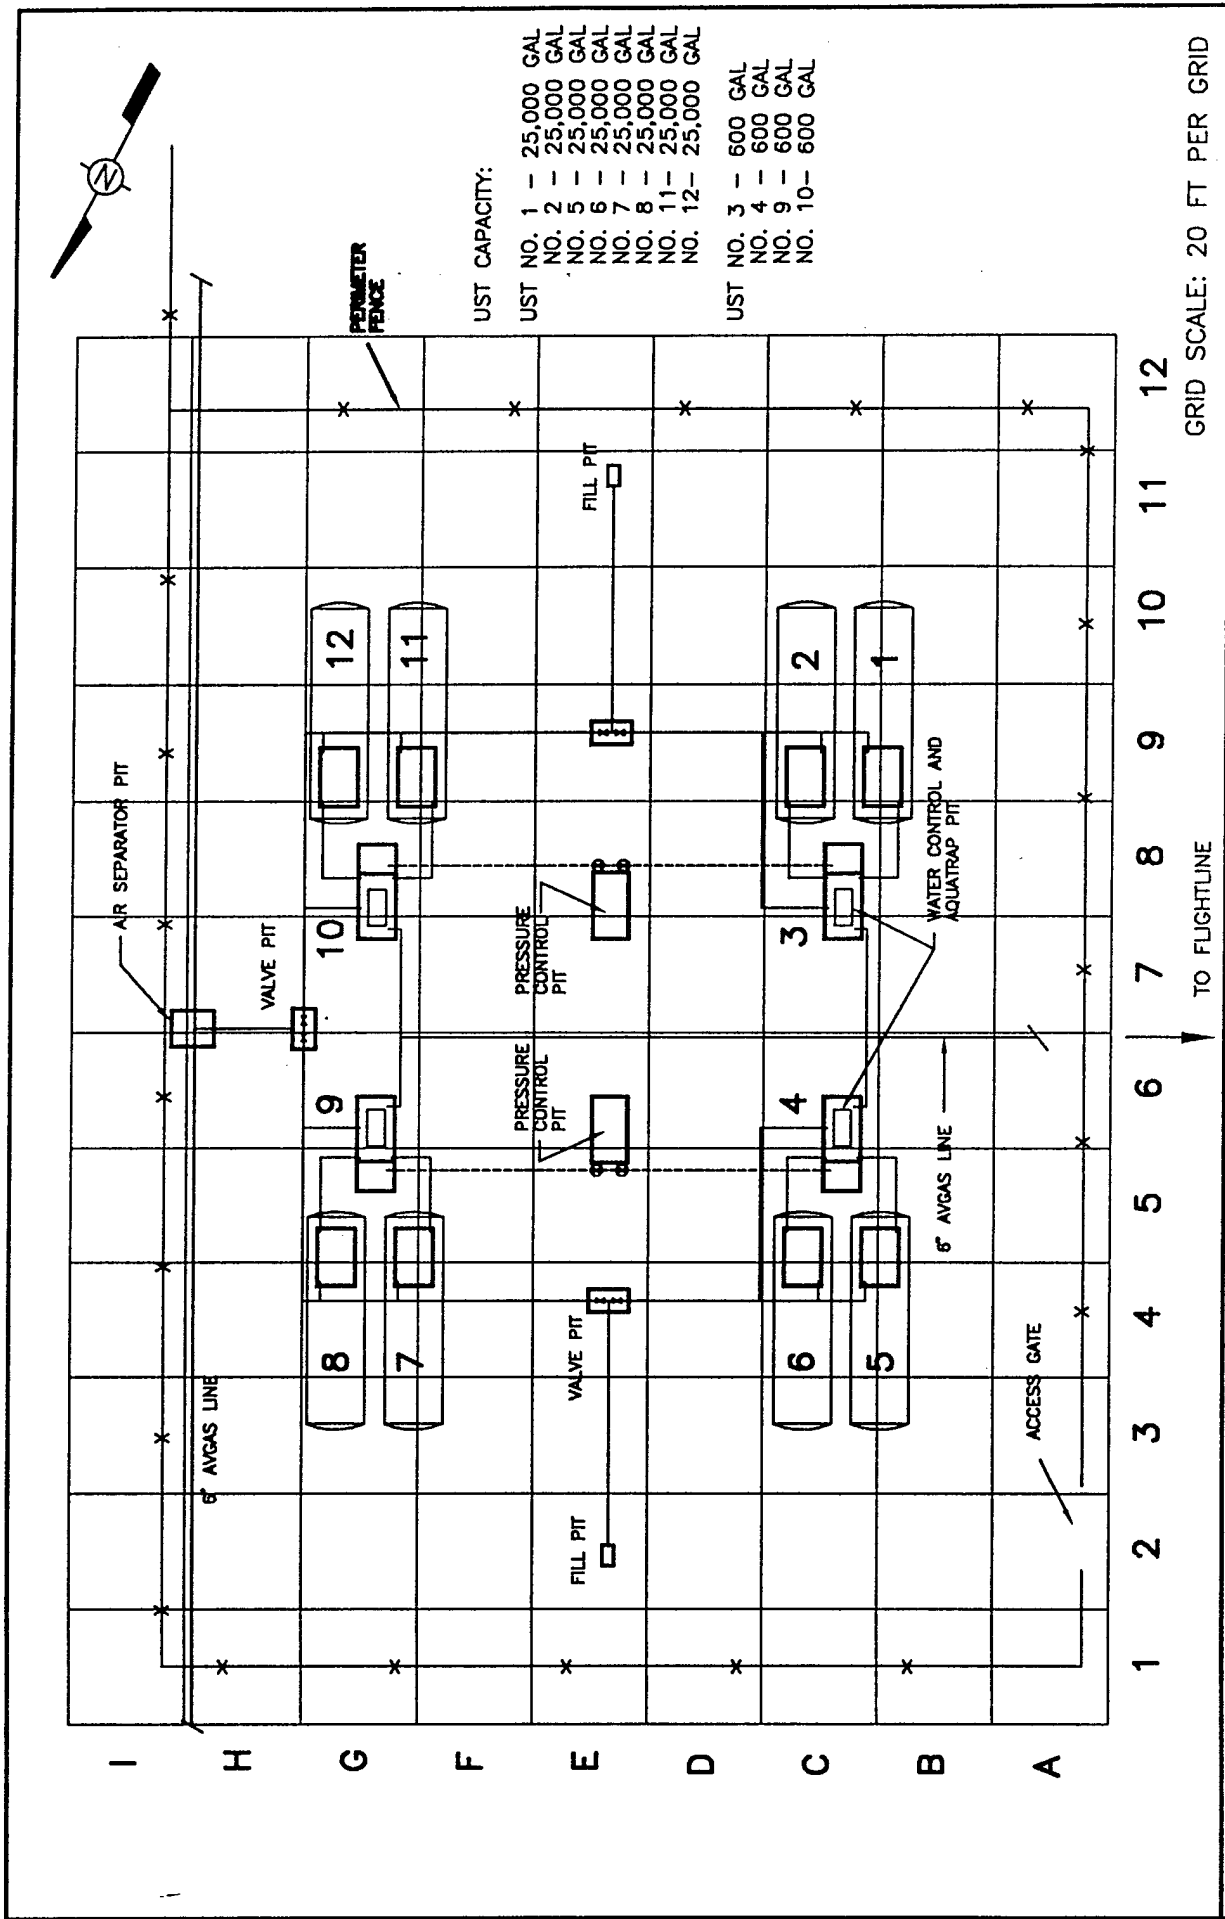
ADVANCED SCIENCES, INC. FILE: RANG41 DATE: 1996		FIGURE 3.4 Site 5 - POL Facilities	VANG BASE 192nd Tactical Fighter Group Richmond International Airport Sandston, Virginia

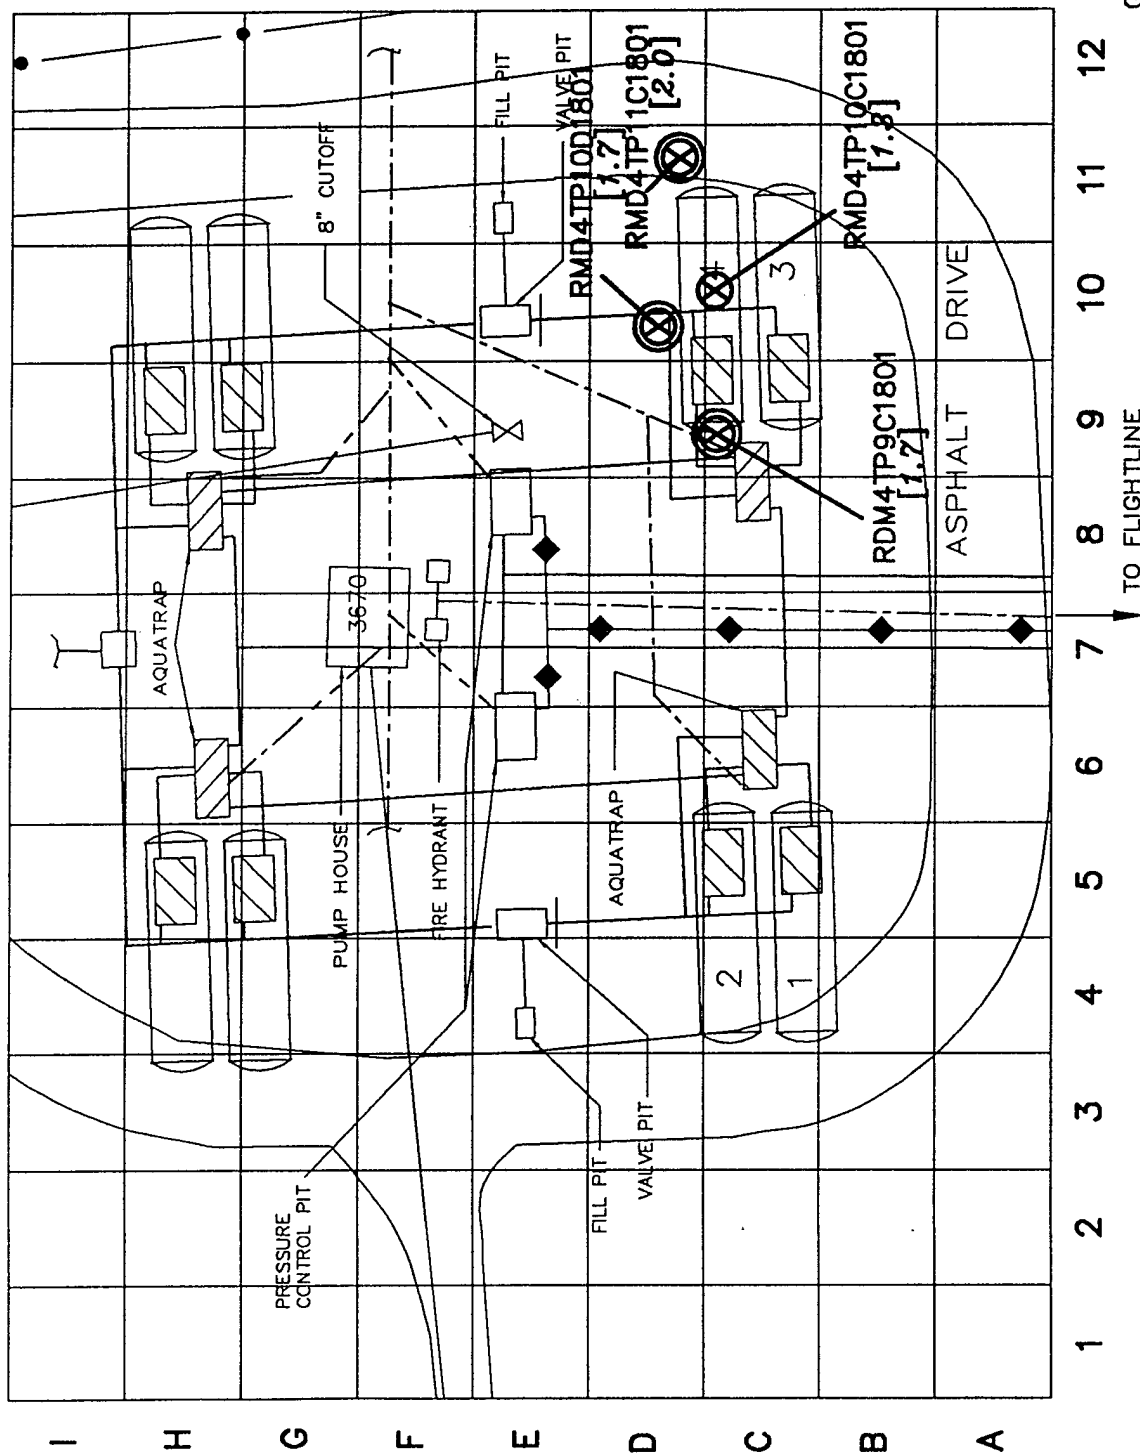
FIGURE 4.2

Site 4 - Total Metals, Arsenic Analytical Results,
UST Pit No. 4

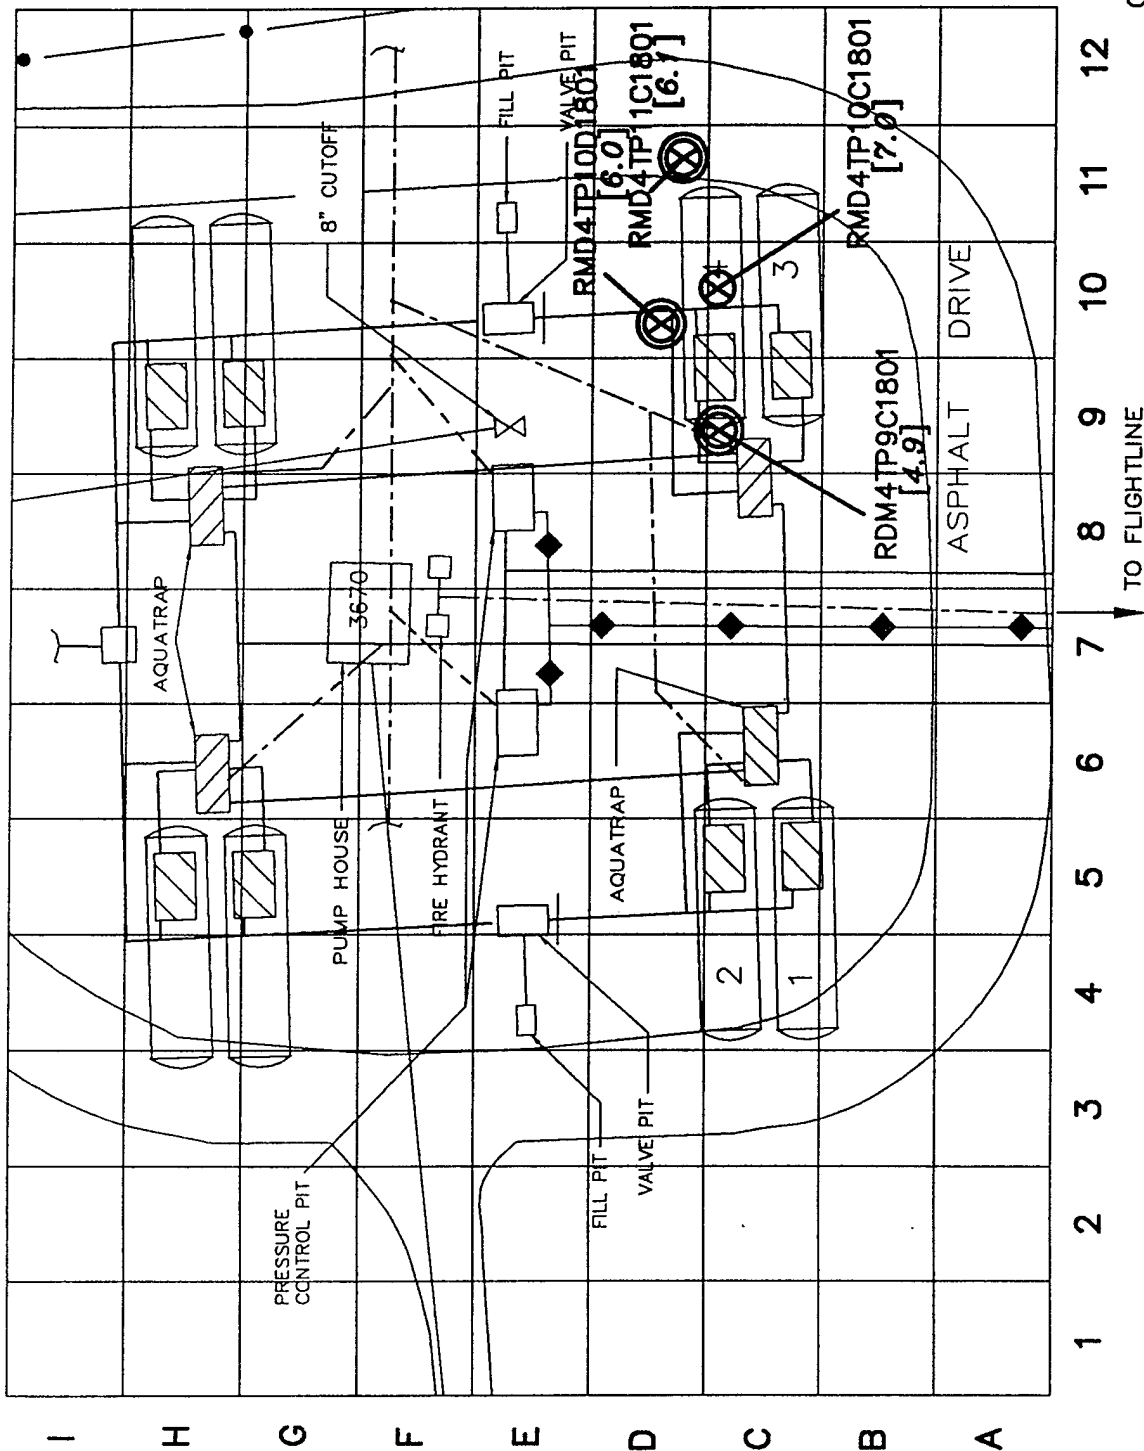
FIGURE 4.4

Site 4 - Total Metals, Chromium Analytical
 Results, UST Pit No. 4

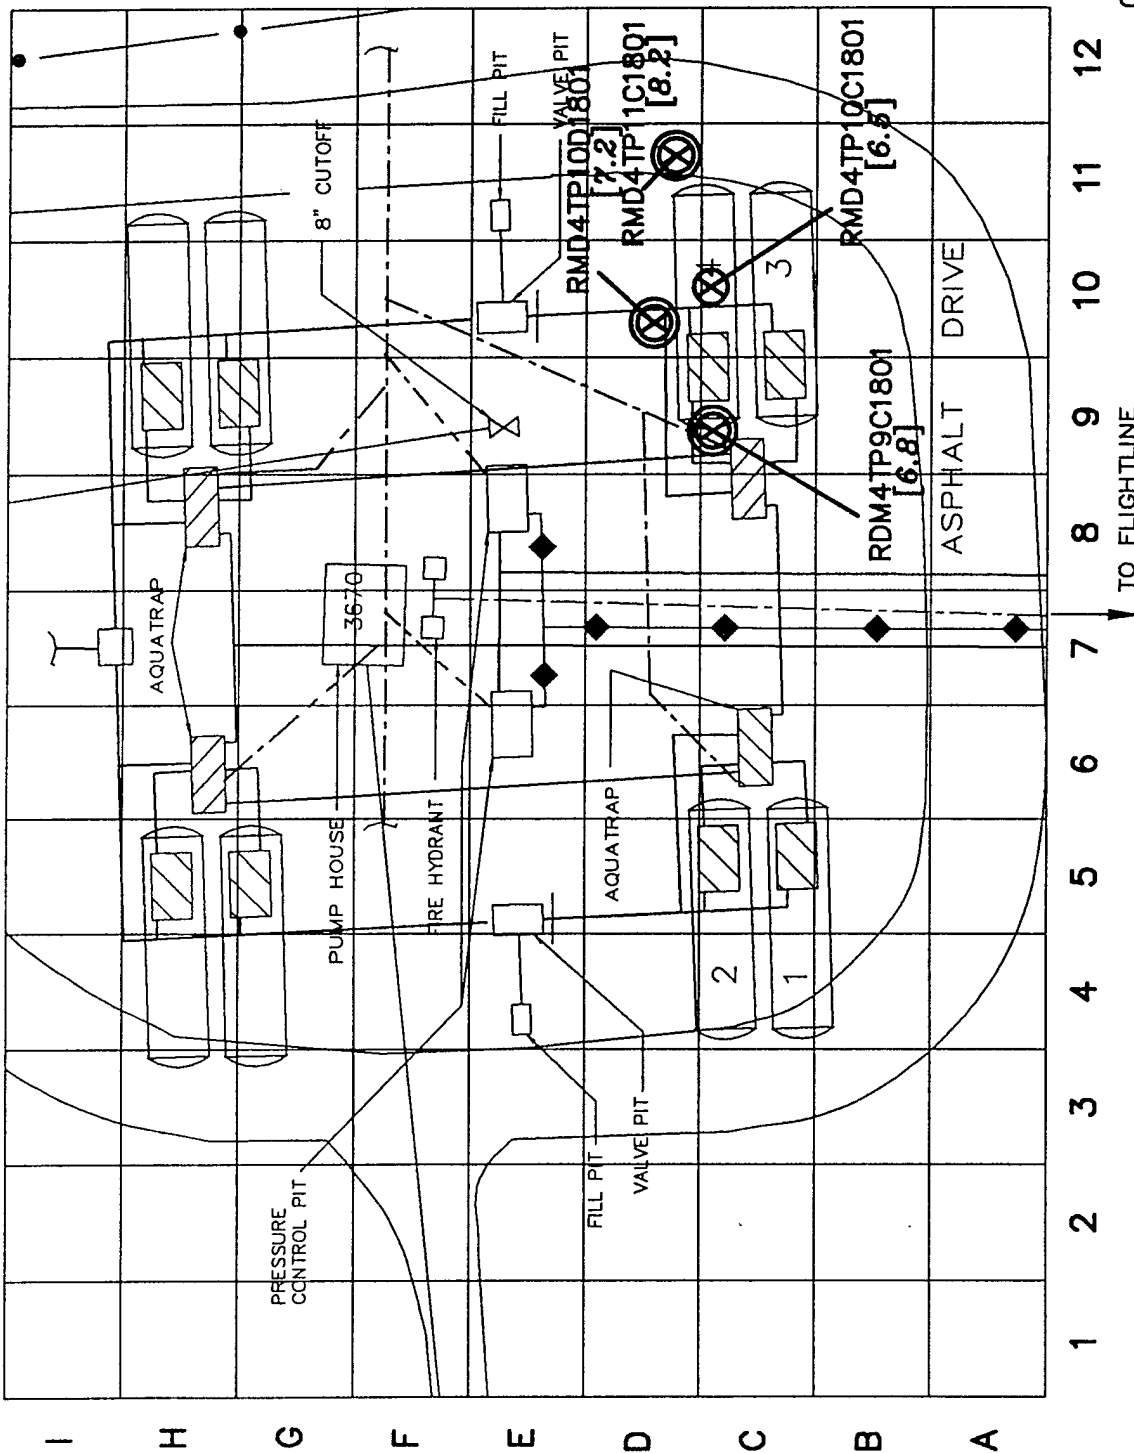
FIGURE 4.5

Site 4 - Total Metals, Lead Analytical Results,
 UST Pit No. 4

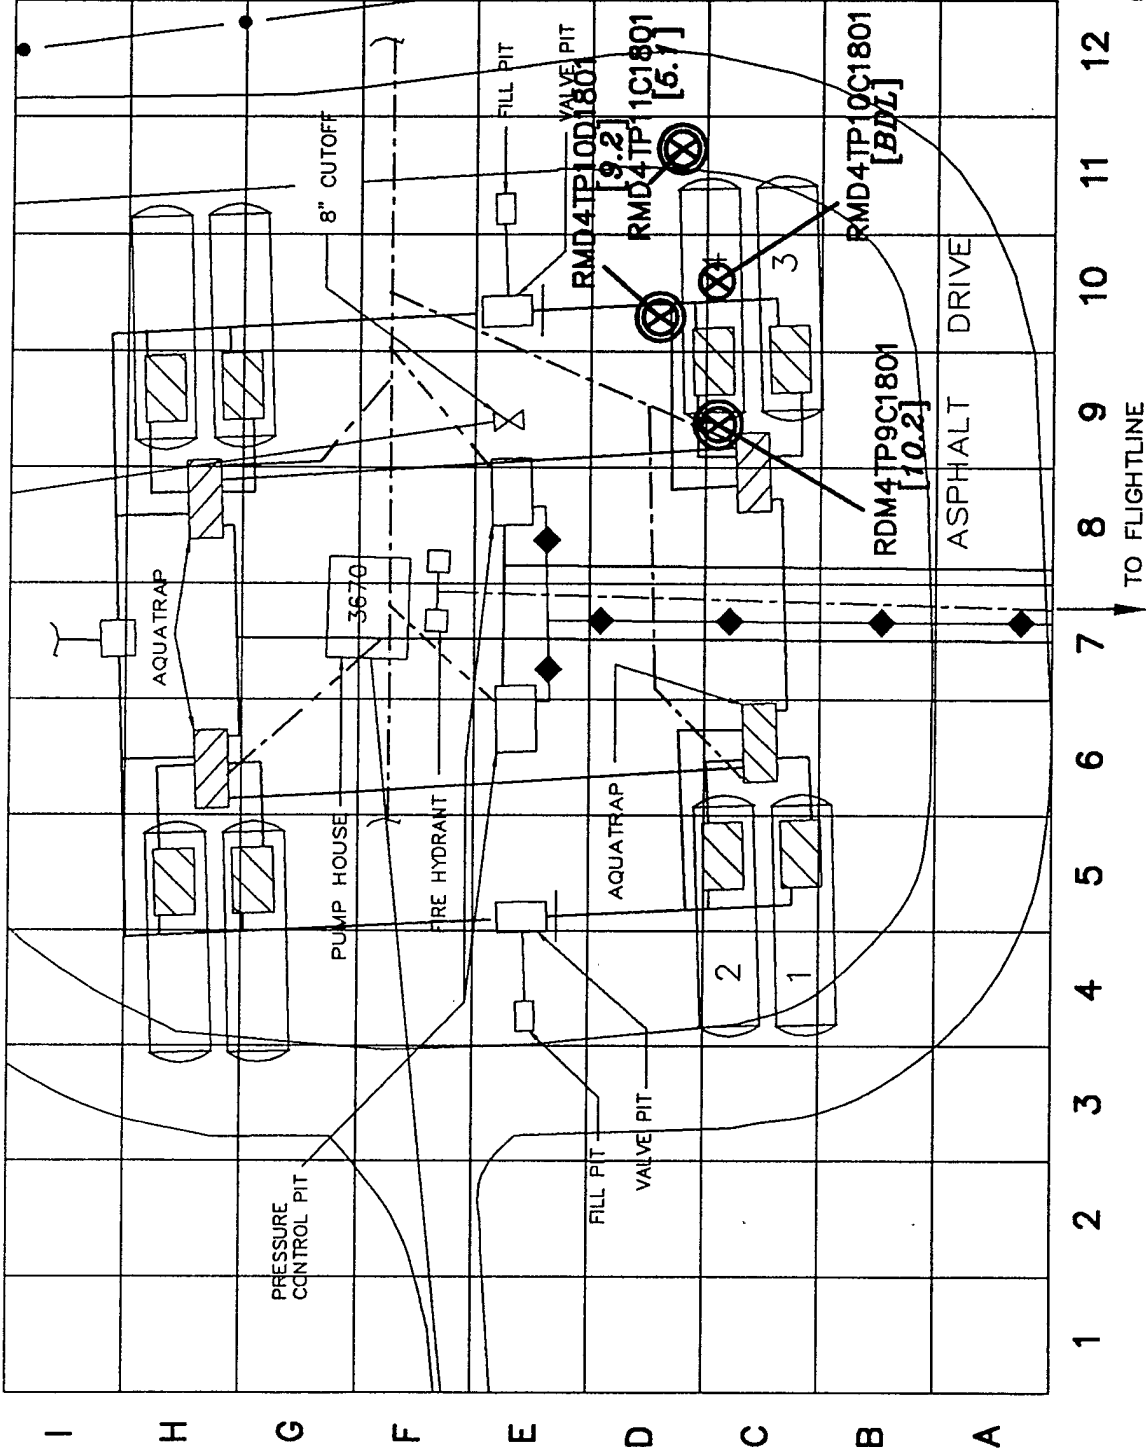
FIGURE 4.6

Site 4 - Methylene Chloride Results,
 UST Pit No. 4

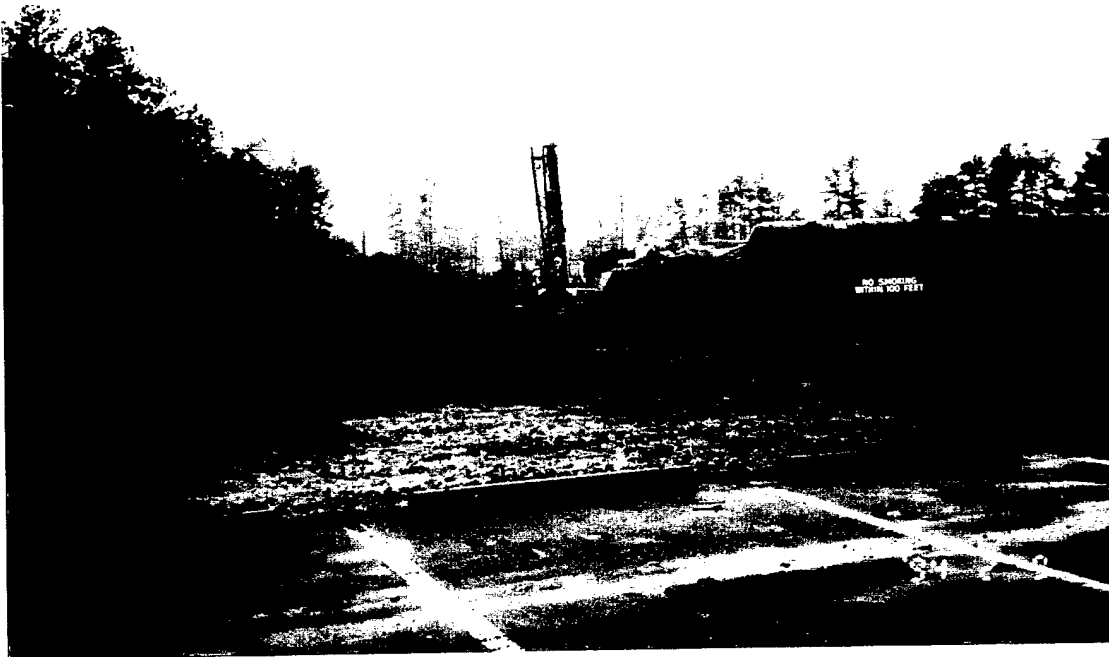
Site 4 - UST No. 4 Removal. View to the North.
(Photo Log No. 7; Roll No. 6/Frame No. 1)

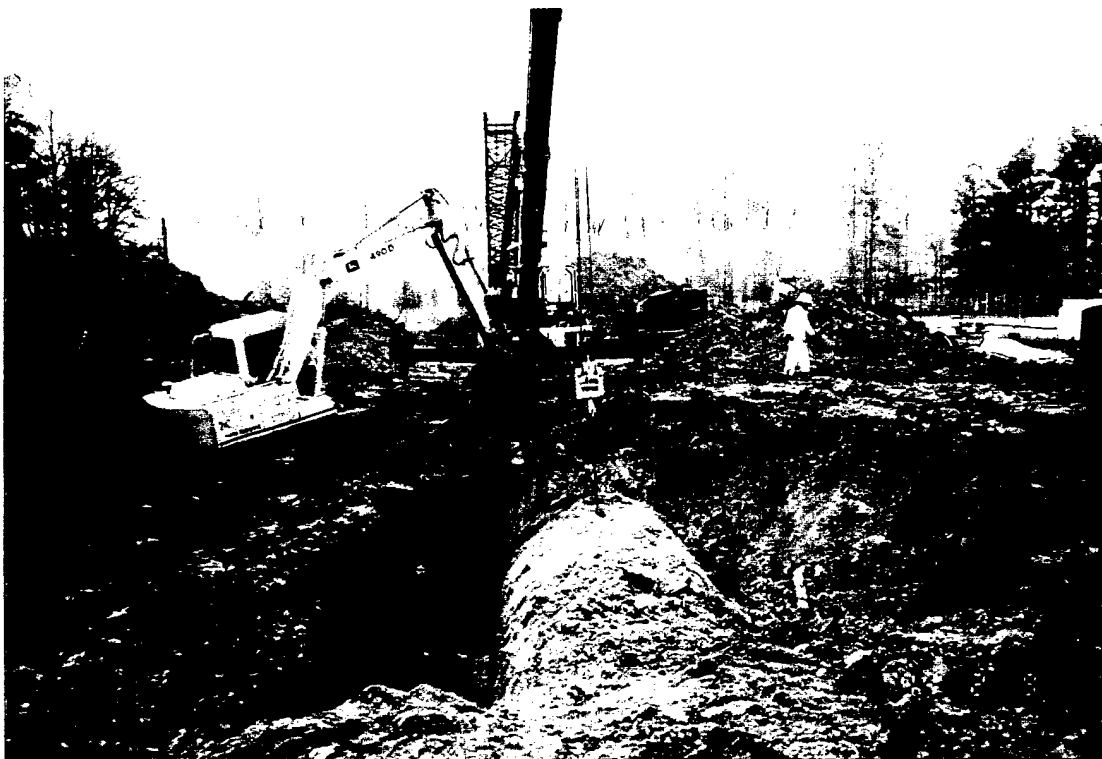
Site 4 - UST No. 4 Removal. View to the North.
(Photo Log No. 7; Roll No. 6/Frame No. 3)

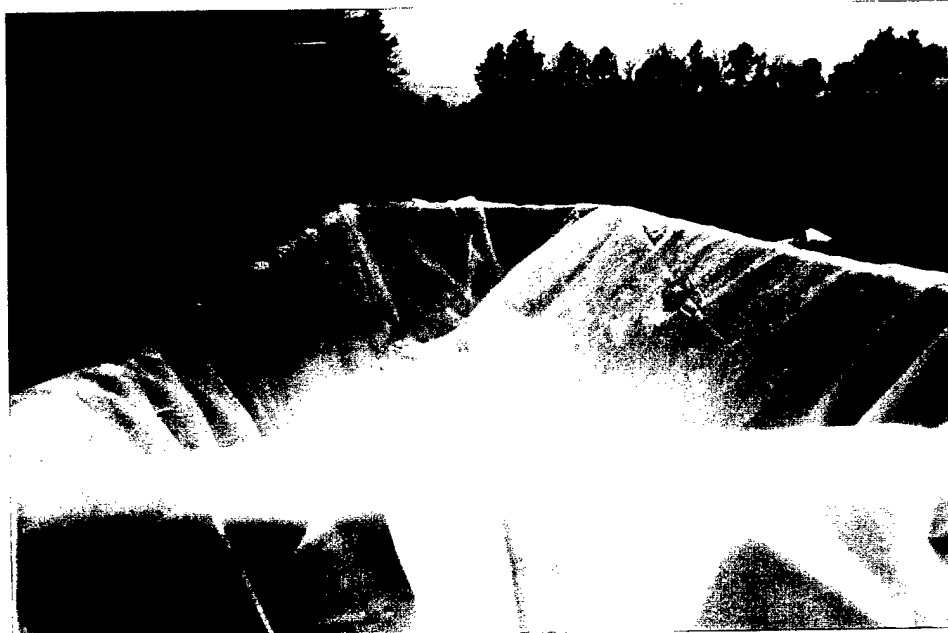
Site 4 - UST No. 4 Removal. Plastic Lined Roll-off Containers
Prior to Loading with Soil. View to the Northwest.
(Photo Log No. 6; Roll No. 5/Frame No. 4)

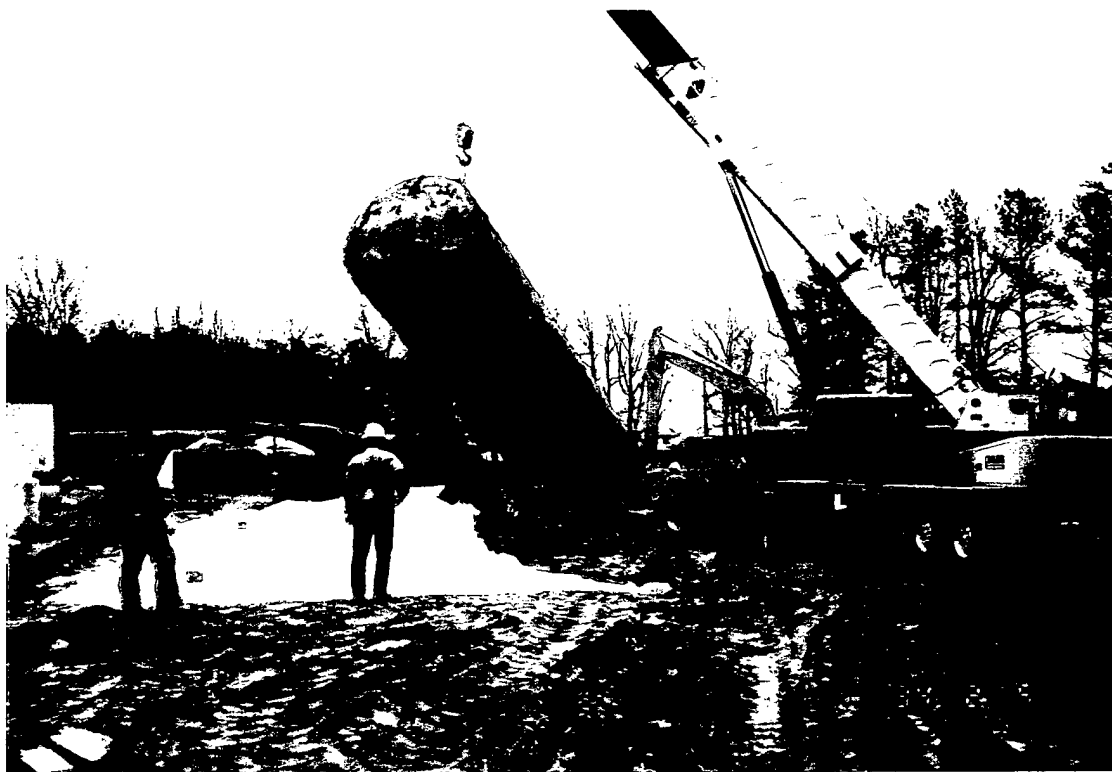
Site 4 - UST No. 4 Removal. View to the South.
(Photo Log No. 7; Roll No. 6/Frame No. 20)

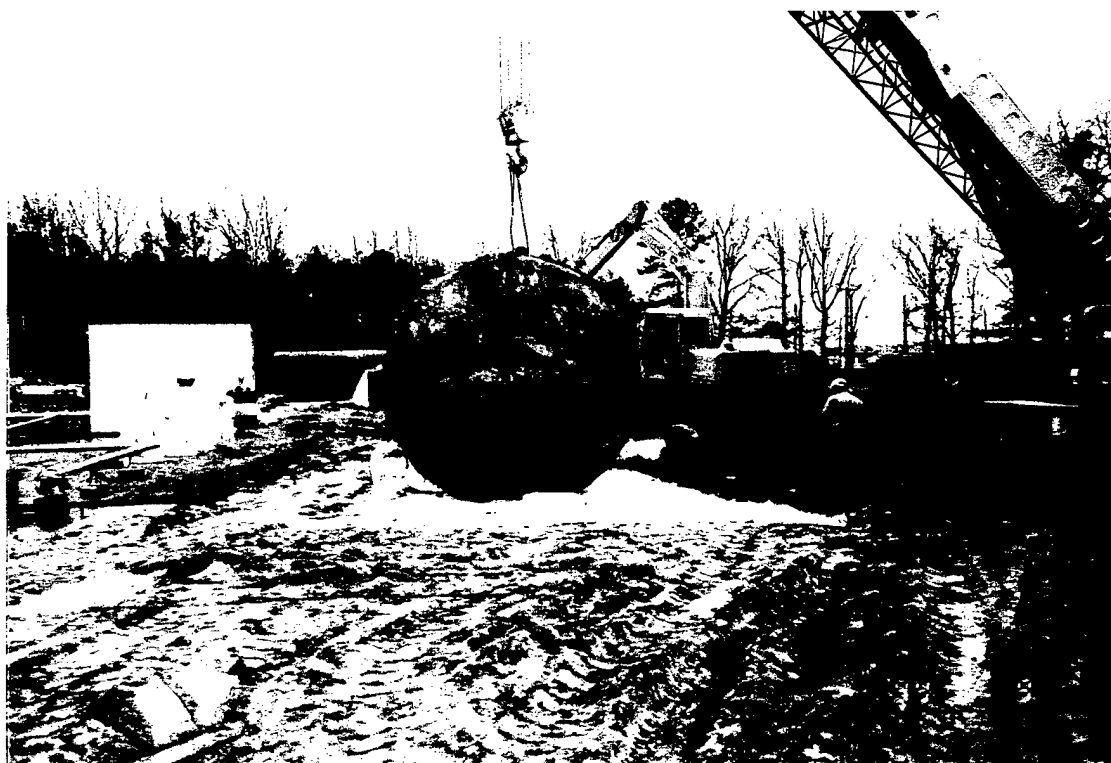
Site 4 - UST No. 4 Removal. View to the South.
(Photo Log No. 7; Roll No. 6/Frame No. 23)

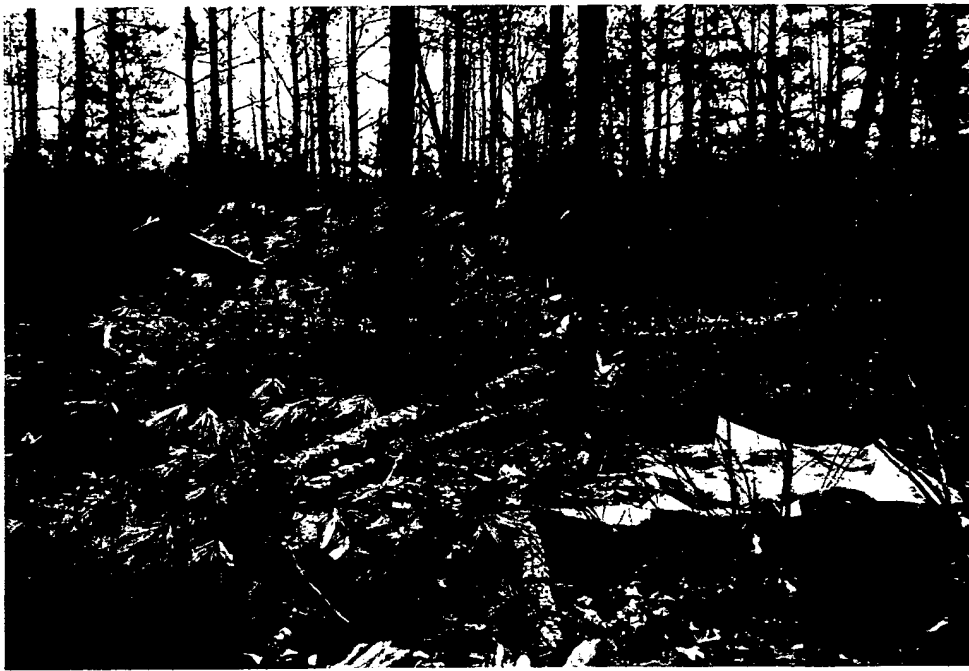
Site 5 - Grubbing Operations, UST Nos. 5/6. View to the East.
(Photo Log No. 1; Roll No. 1/Frame No. 1)

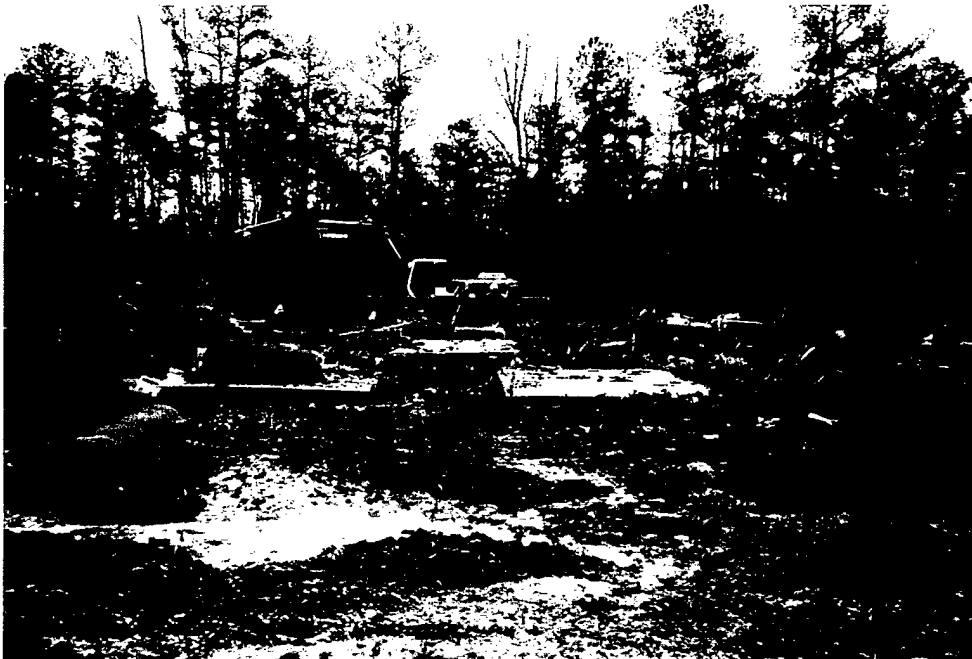
Site 5 - After Grubbing Operations, UST Nos. 7/8. View to the Southeast.
(Photo Log No. 2; Roll No. 1/Frame No. 29)

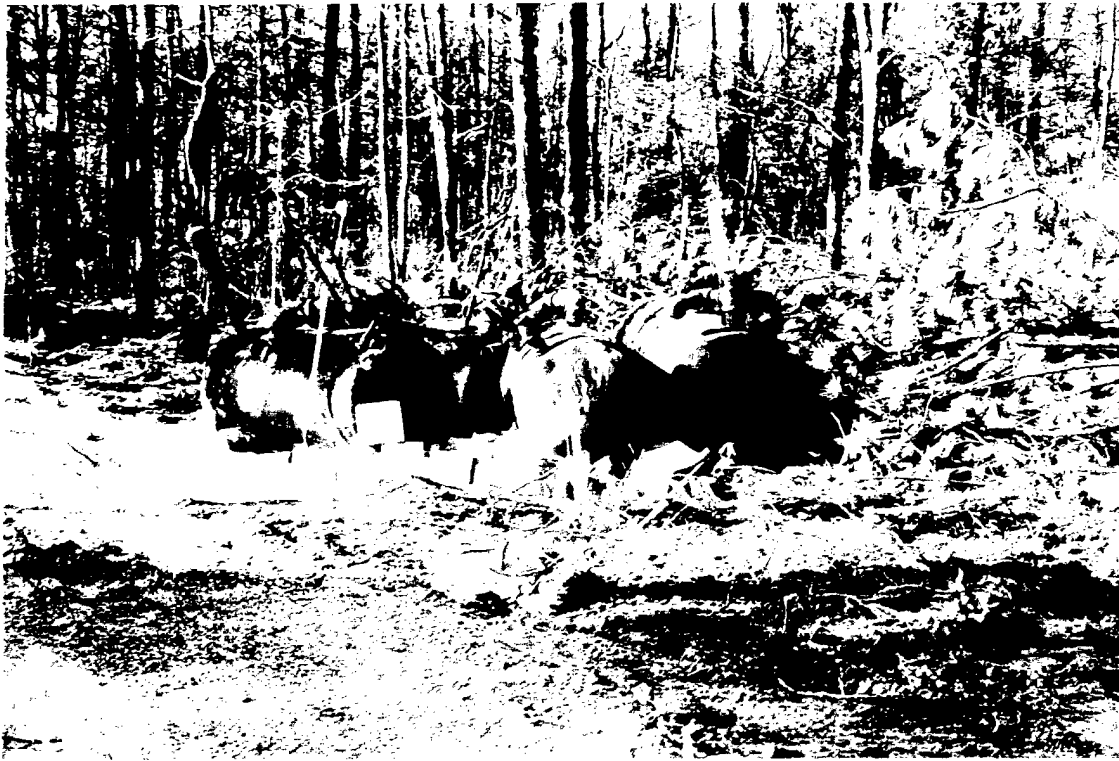
Site 5 - Four 600 gallon Aquatrap USTs After Removal. Temporary Storage Site Located in Northwest Corner of Site 5. View to the Northwest.
(Photo Log No. 4; Roll No. 2/Frame No. 3)

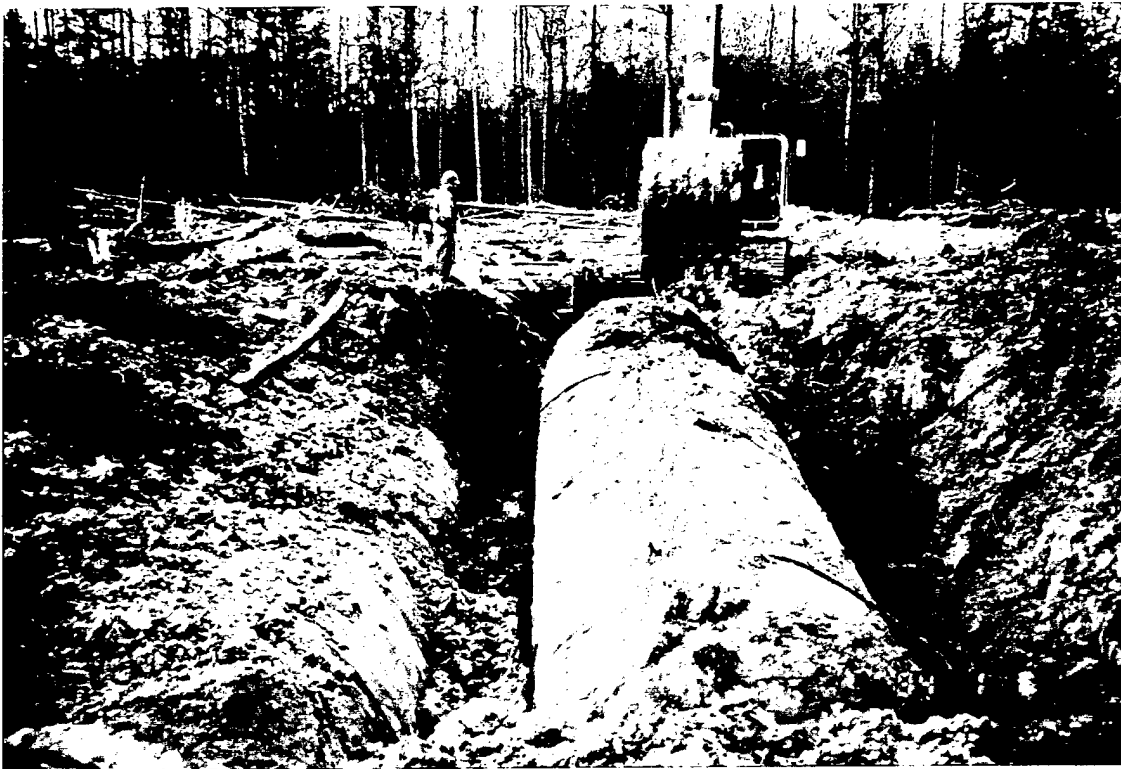
Site 5 - UST No. 12 Removal. View to the Northwest.
(Photo Log No. 4; Roll No. 2/Frame No. 18)
